## SERVICE BULLETIN

### Super Raven Dash-M Series

#### TITLE: LINE ATTACHMENT STRUCTURAL ENHANCEMENT

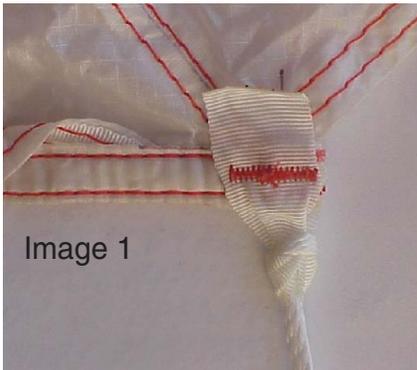
Affected canopies have serial numbers whose last 5 digits are below 35937 and can be further identified by the single 42 stitch bartack in the .75" T-III MIL-T-5038 tape line attachment loops (Image 1).

The seam where the Lower Surfaces join are sewn with a single pass using a double needle machine. The original line attachment loop is secured with a single bartack between the stitch rows of the double needle seam that joins the lower surfaces (Image 1). You will notice that the leading edge of the canopy already has a 28 stitch tack on the loadbearing stitchrow beneath the line loop (Image 3). You will be placing your new bartack right over the top of the existing tack, except that you will be sewing through the Type III loop material as well.

Image 1: Affected canopies have a single 42 stitch bartack pattern in .75 inch T-III tape loop

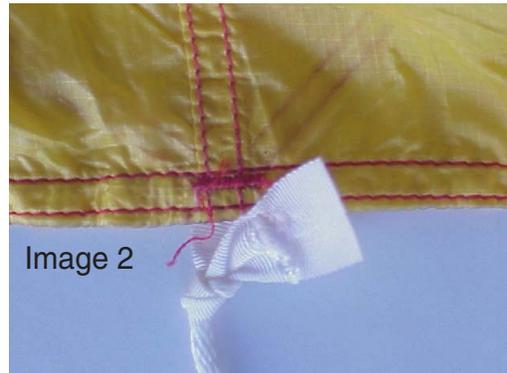
Exceptionally hard opening shocks generated by the subject canopies have prompted this Service Bulletin. Forces generated during opening shock resulted in a cataclysmic compromise of the line attachment system, with collateral damage extending upward generating torn canopy fabric and downward generating broken lines. The initial point of failure appeared to be similar in both cases, beginning in the region of the off-center A line attachment point. Subsequently, transient loading migrated outward and rearward affecting the integrity of some of the adjacent line attachment loops.

The failure mode was in the destruction of the .75 x T-III MIL T-5038 line attachment loop tape, manifested by pulling the attachment loop tape away from the canopy but leaving the associated stitching intact (image 2).

Image 2: Damage at one of the 'B' line attachment points

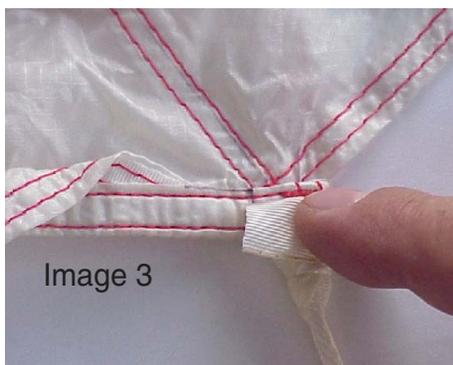
Image 3: Pulling back the line attachment loop reveals the 28 stitch tack in the leading edge.
